MISCELLANEOUS PAPER SL-86-14

# ABRASION-EROSION EVALUATION OF CONCRETE MIXTURES FOR STILLING BASIN REPAIRS, KINZUA DAM, PENNSYLVANIA

September 1986

Prepared for US Army Engineer District, Pittsburgh  
Pittsburgh, Pennsylvania 15222-4186

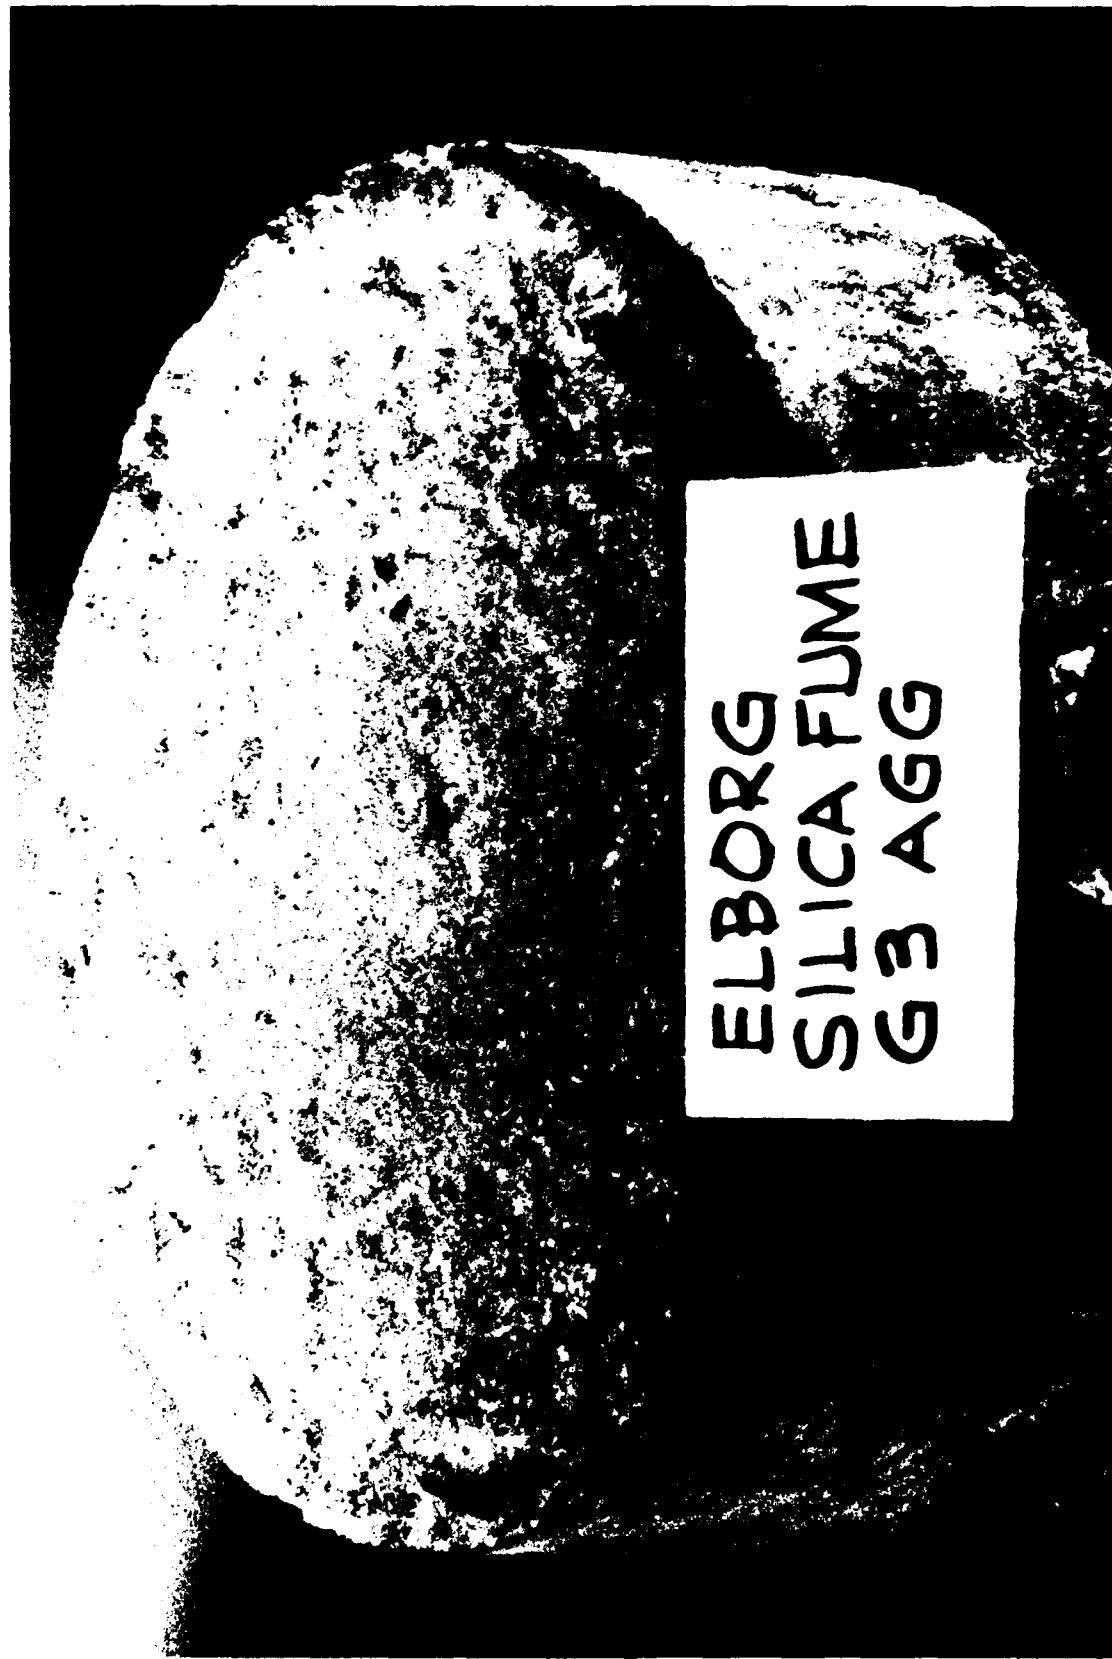
Figure 3. Abrasion-erosion specimen at conclusion of testing, Mixture G3 (Elborg product)

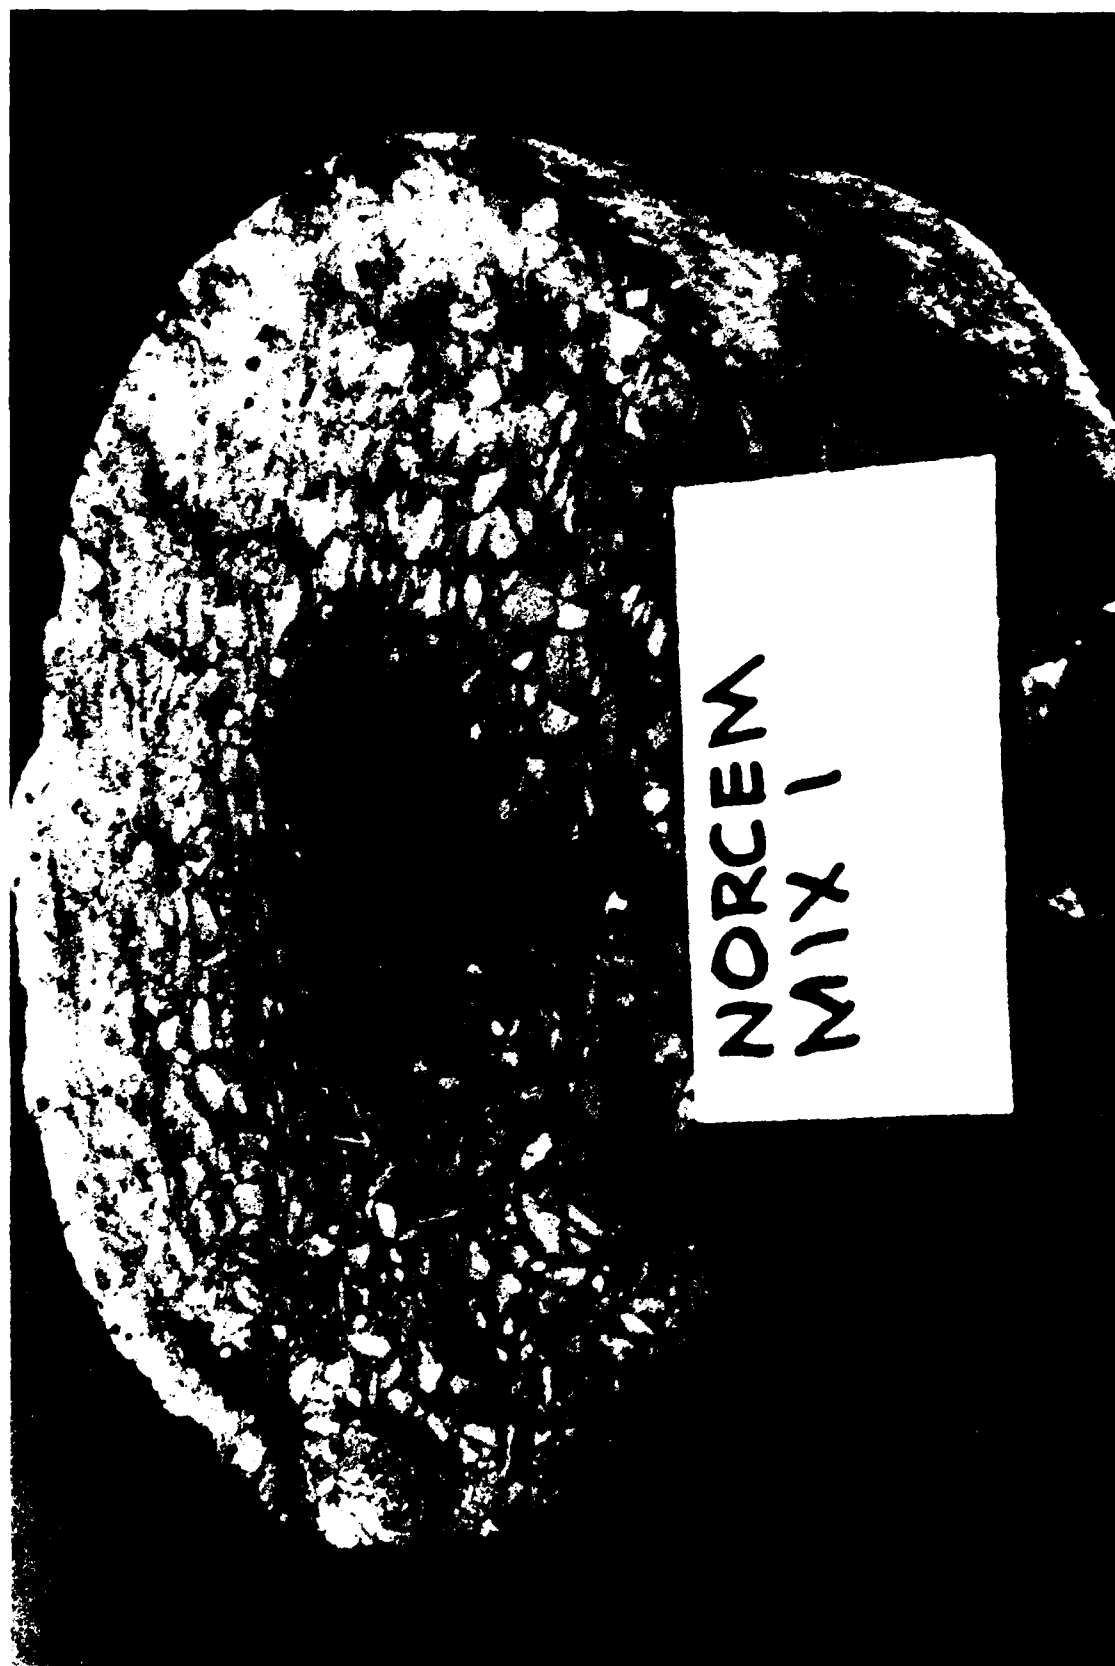
Figure 5. Abrasion-erosion specimen at conclusion of testing, Mixture Norcem 1  
from Neville Island trial placements

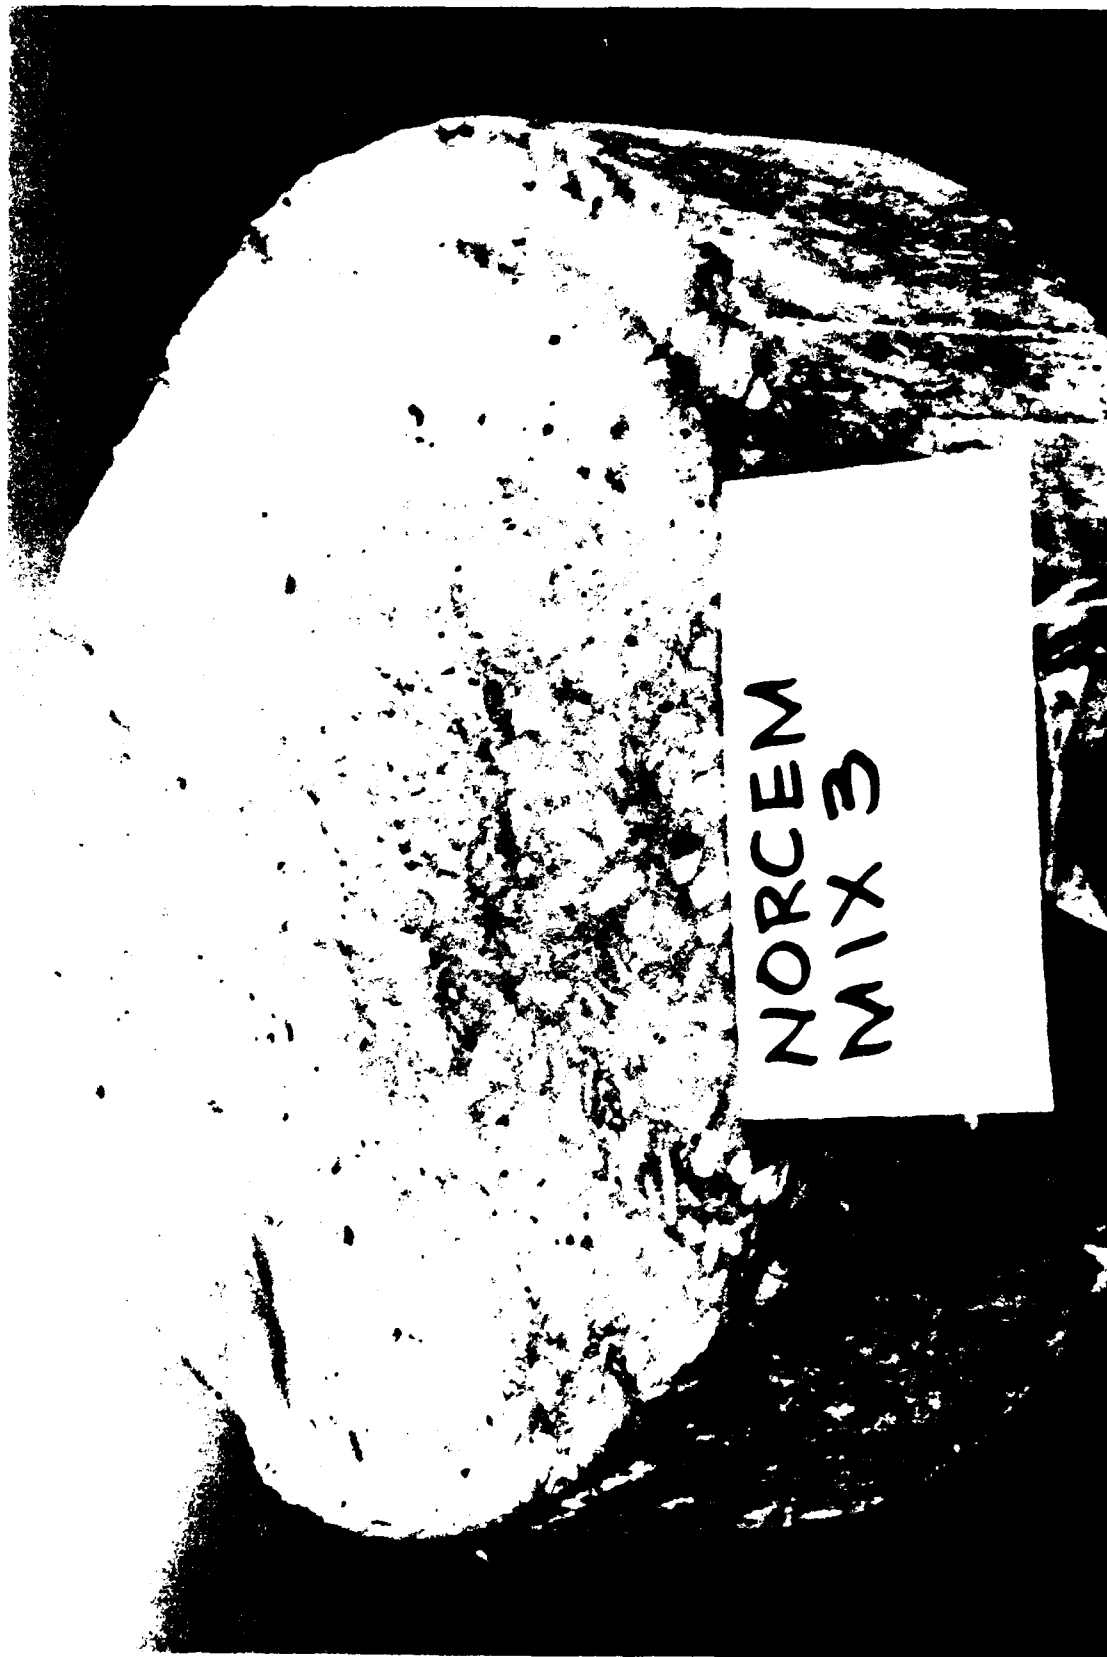
Figure 6. Abrasion-erosion specimen at conclusion of testing, Mixture Norcem 3 from Neville Island trial placements

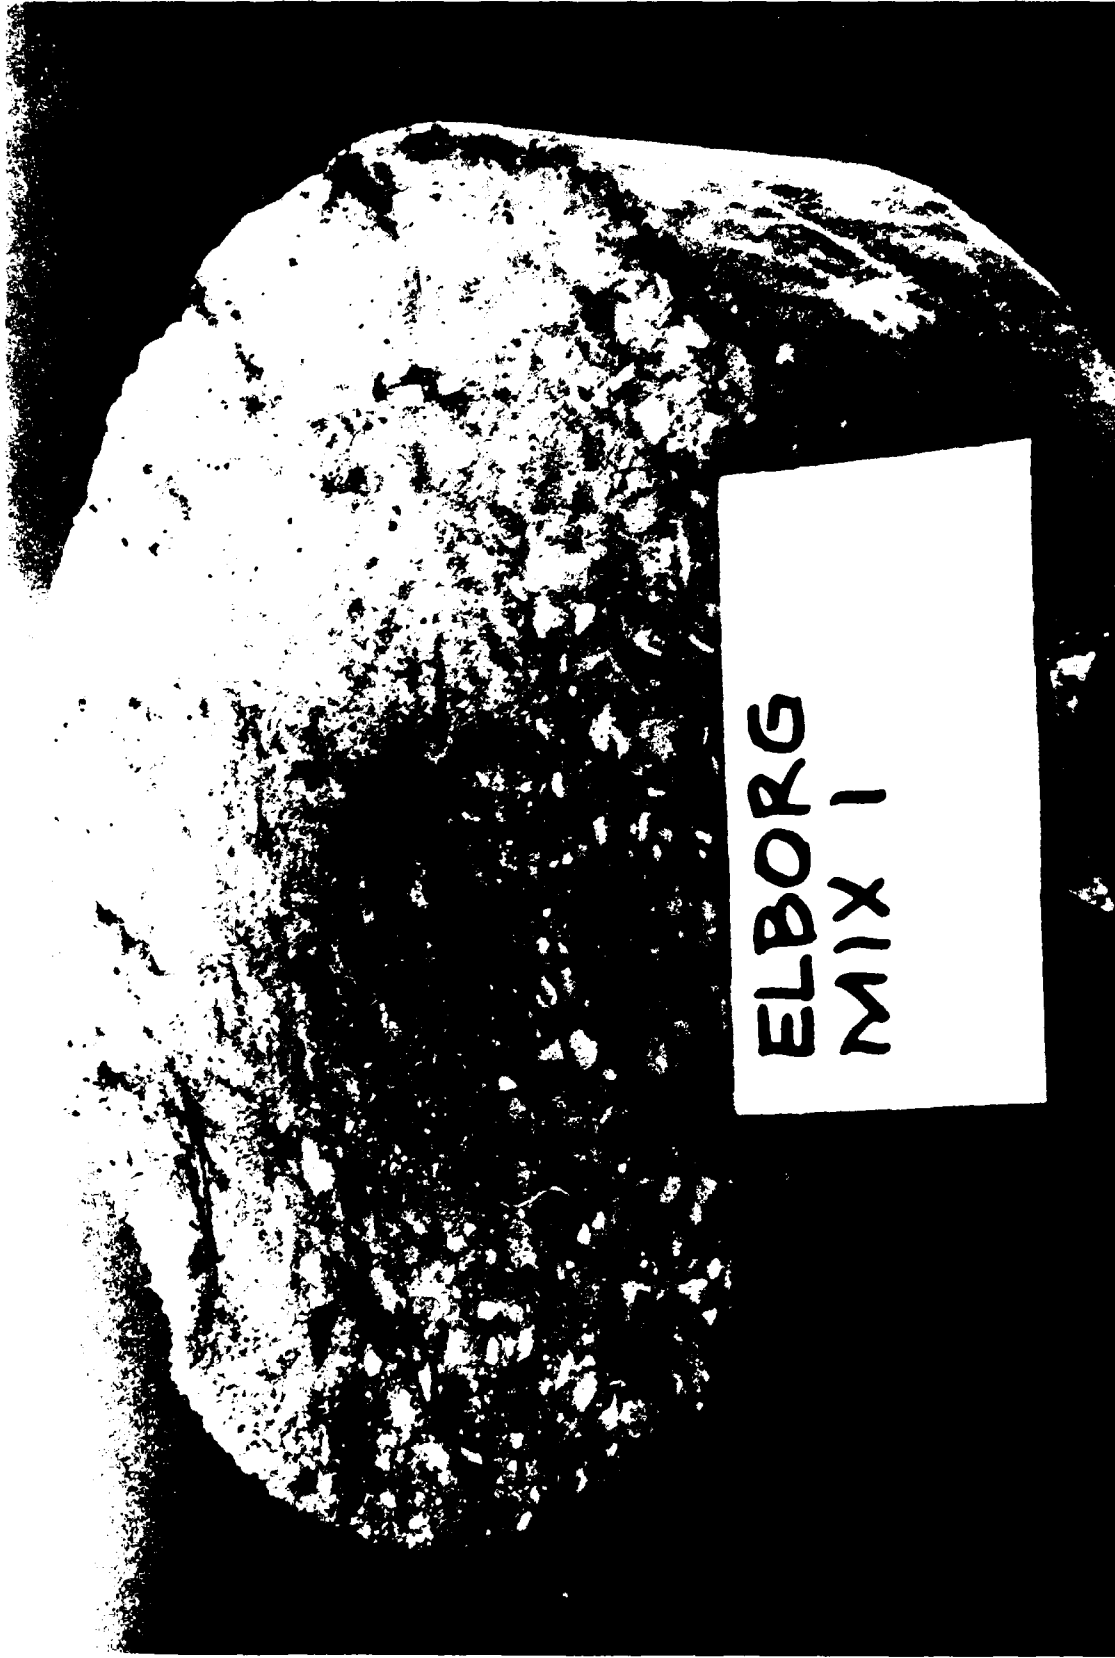
Figure 7. Abrasion-erosion specimen at conclusion of testing, Mixture Elborg 1 from Neville Island trial placements

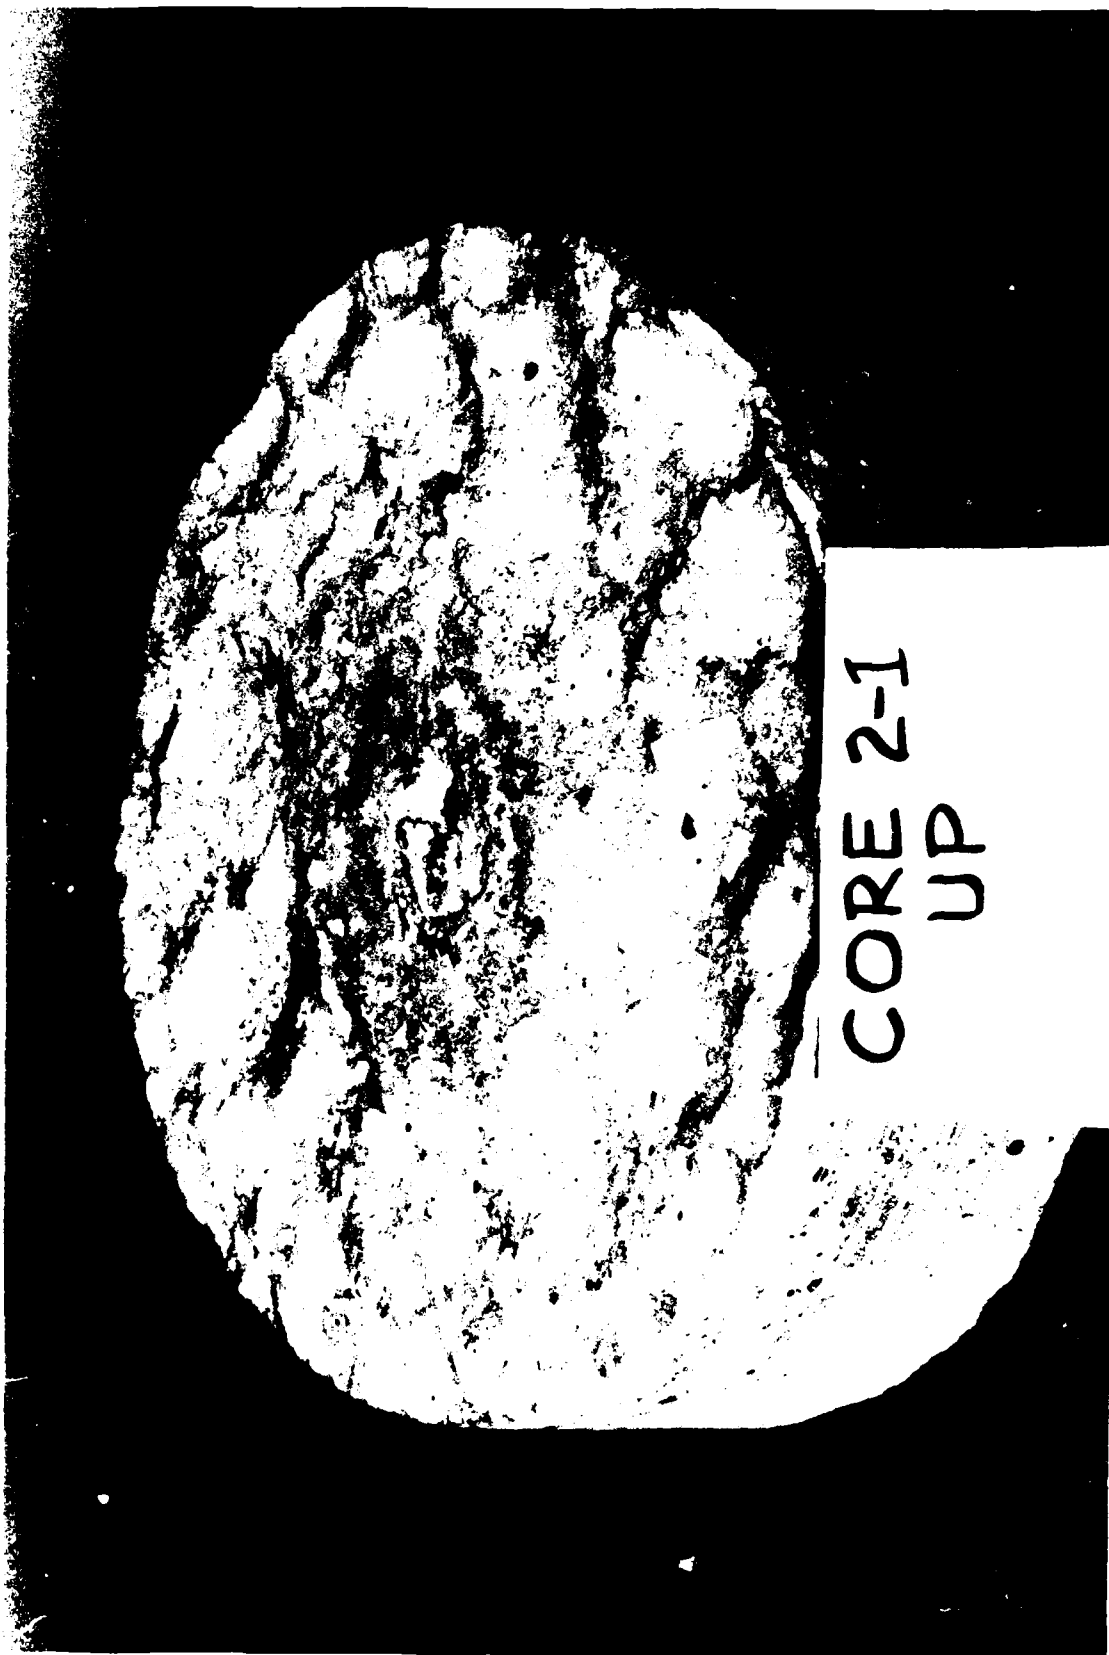
Figure 12. Abrasion-erosion specimen at conclusion of testing, core ORP No. 2-1 from Neville Island trial placements, upper surface tested

- d. The plastic shrinkage cracks in the two Norcem specimens tested did not have a significant effect on the abrasion resistance. The higher abrasion loss seen when these samples were inverted and tested suggests that the finishing process produced a very dense concrete near the surface, while the concrete below the surface was not as dense. This thought is in keeping with the low amount of vibration seen during the Norcem placements.

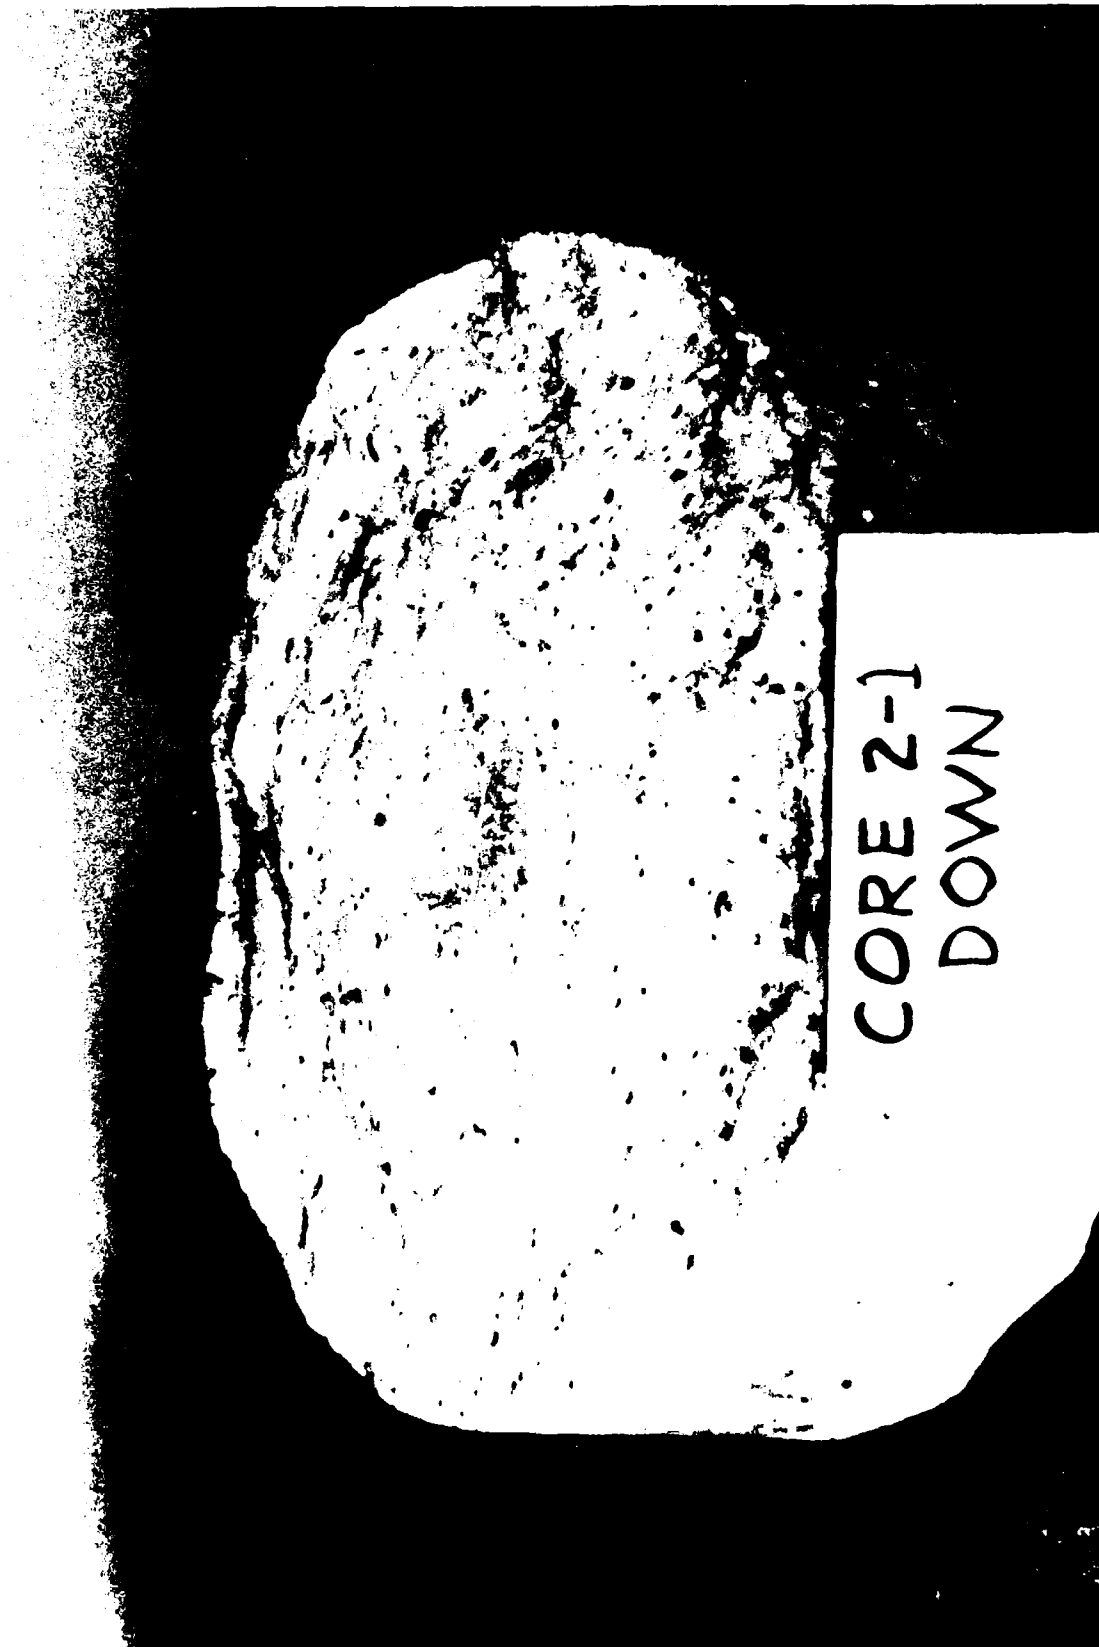
Figure 15. Abrasion-erosion specimen at conclusion of testing, core ORP No. 2-1  
from Neville Island trial placements, lower surface tested

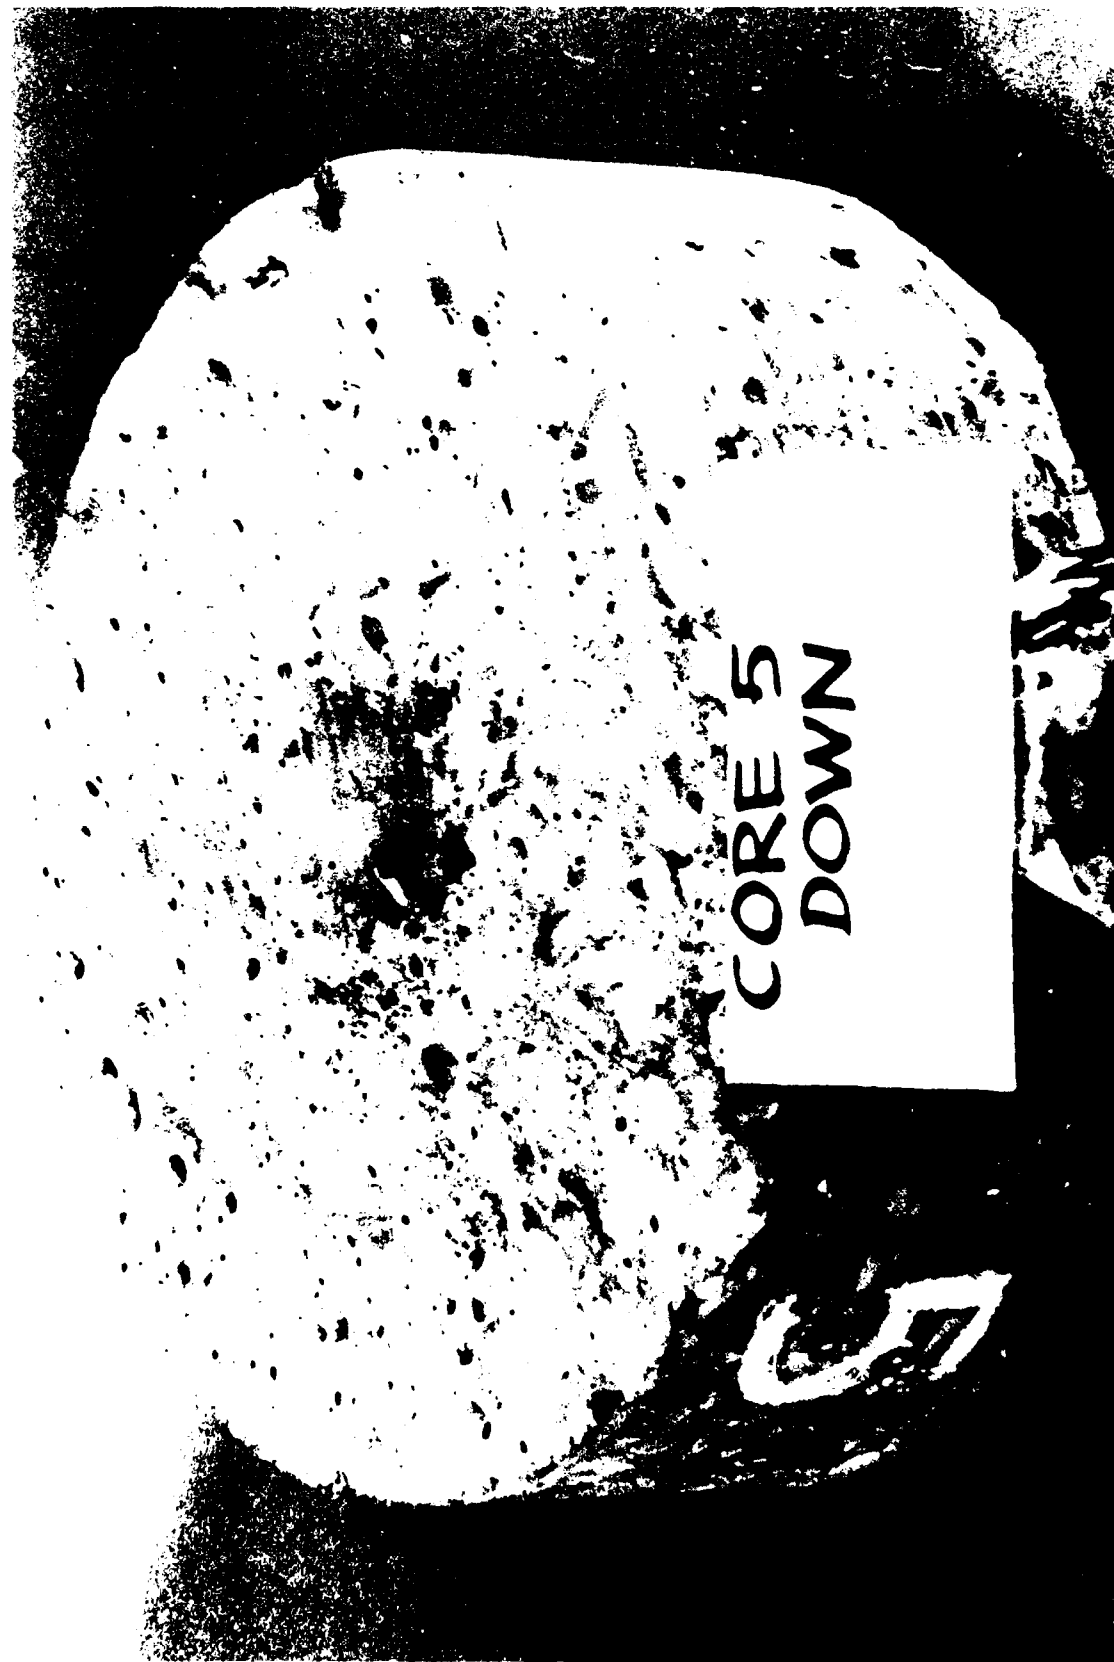
Figure 17. Abrasion-erosion specimen at conclusion of testing, core ORP No. 5 from Neville Island trial placements, lower surface tested

- e. The rough surface of the one Elborg core tested did not cause a significant increase in abrasion loss. The lower loss seen when this specimen was inverted (2.5 versus 3.6 percent) may indicate that the Elborg concrete consolidated very well at the location of the core. However, with only one sample, it is very difficult to draw many conclusions.
